# Engineering Failure Analysis

## The progressive failure of 15 balconies and the engineering techniques for their reconstruction

Rafael Alves de Souza <sup>a,\*</sup>, Mauro José de Souza Araújo <sup>b</sup><sup>a</sup> Universidade Estadual de Maringá, Av. Colombo, 5790 Bloco C67, CEP 87020-900, Maringá, PR, Brazil<sup>b</sup> Centro Universitário de Maringá, Av. Colombo, 5790 Bloco C67, CEP 87020-900, Maringá, PR, Brazil

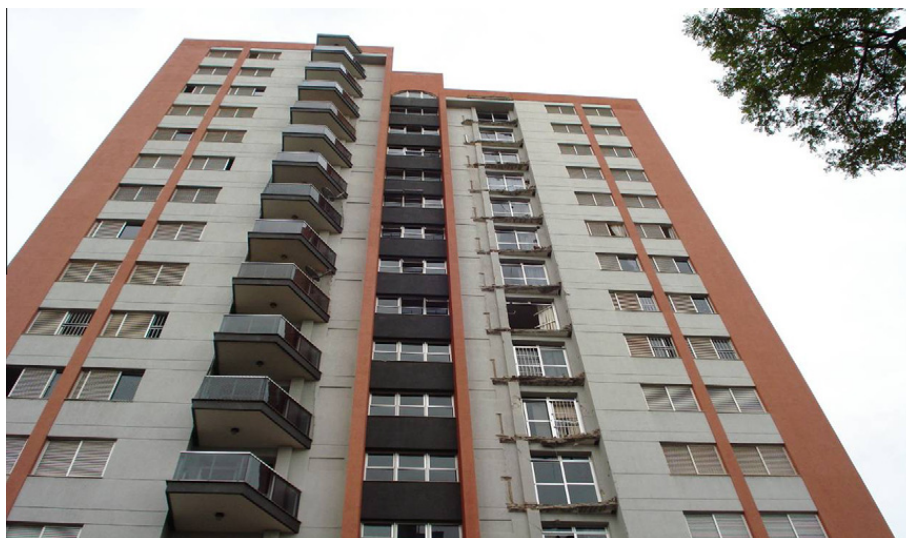
Located in a prime area of Maringá, the damaged housing building has a terrace, a subsoil garage and 15 levels with two apartments by floor. Fig. 1 presents the building frontage, where is possible to detect the progressive failure occurred in the right side of the construction.

As can be seen in Fig. 1, there were two identical columns of suspended balconies in the principal façade of the building. This balconies had trapezoidal format with an approximated area of 2.00 m<sup>2</sup> as shown in Fig. 2a. The architectural project had specifications for a small pot plant at the corner of the balcony as well as a glass grid. However, there was no specification about the coating that should be used in the balconies floors.

Fig. 1. Progressive failure of balconies of a housing building in Maringá (Brazil).

Approximately 12 years after recording this first incident in the vicinity, the building in question has passed by another damage situation, once again without presenting victims. At the dawn of October 26th 2008, occurred the progressive collapse of one canopy and 15 reinforced concrete balconies throughout the frontage of the building, as previously shown in Fig. 1.

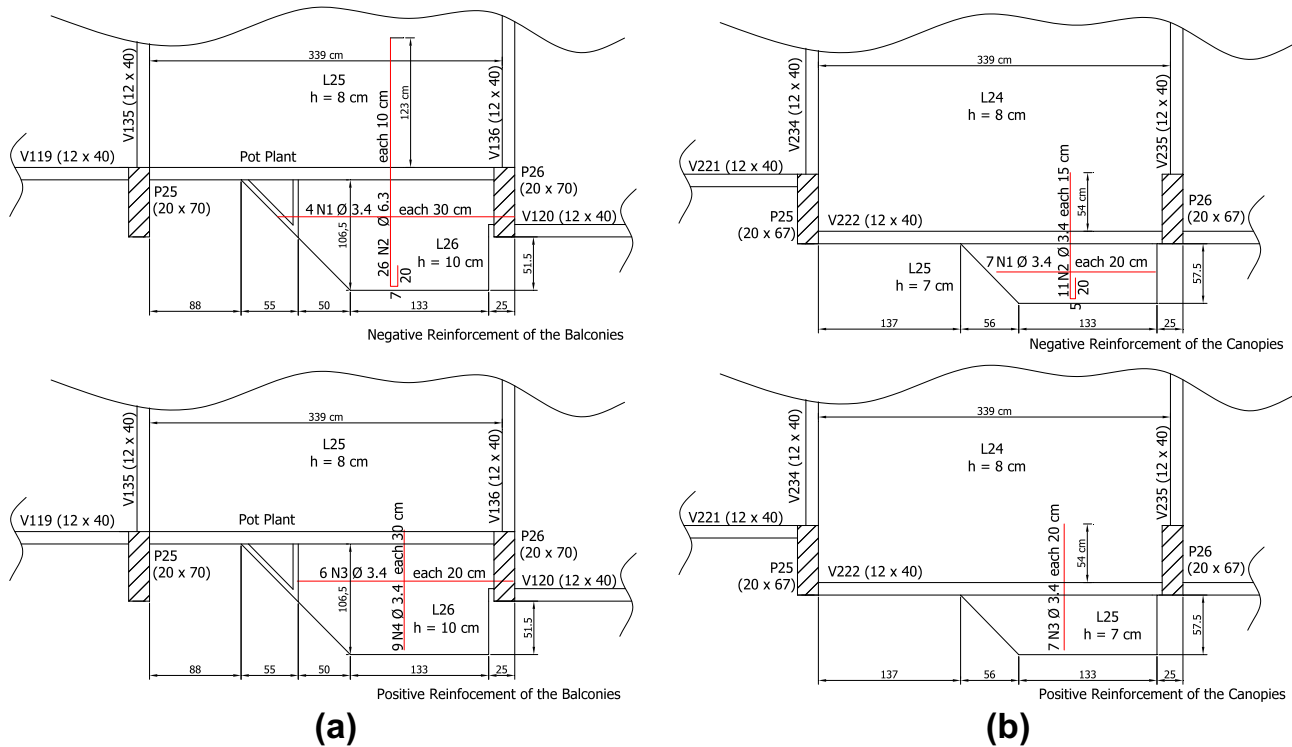
The positive and negative reinforcements used for the cantilevered slabs of the balconies are shown in Fig. 2a. The analysis of the structural drawings revealed that the slabs designed for the balconies should have a thickness of 10 cm, concrete cover of 1.5 cm, concrete with characteristic compressive strength of 15 MPa and steel bars with yielding characteristic strength of 600 MPa.

For the canopies of the 15th pavement were also used cantilevered slabs which were linked to the adjacent slabs of the terrace (L24), as shown in Fig. 2b. The cantilevered canopy slabs were specified to have a thickness of 7 cm, concrete cover of 1.0 cm, concrete with characteristic compressive strength of 15 MPa and steel bars with yielding characteristic strength of 600 MPa.

Fig. 2. Dimensions and reinforcements of (a) balconies and (b) canopies.

As can be realized, the negative reinforcement specified by the structural engineer in the structural drawing, i.e., bars of 3.4 mm of diameter spaced each 15 cm ( $A_s \cong 0.54 \text{ cm}^2/\text{m}$  as shown in Fig. 2b), is practically twice times the negative reinforcement calculated based on the features presented on the architectural drawing. Also, the amount of negative reinforcement specified by the structural engineer satisfies the minimum reinforced recommend by the Brazilian structural code in that time, i.e., [1]. Based on a cracking moment  $1.22 \text{ kN m/m}$  for the canopy, the mentioned code would lead to a negative reinforcement of  $0.58 \text{ cm}^2/\text{m}$ , practically the same reinforcement specified by the structural engineer.

Additionally, as can be seen in Fig. 2a, the balconies have been specified in the architectural and structural drawings for having a span of 106.5 cm and a length of 233 cm. In the failed balconies as well as in the reminiscent balconies was possible to verify a span of 150 cm and a length of 254 cm. It should be observed that even with this modification the longitudinal main reinforcement (negative reinforcement) was not updated.

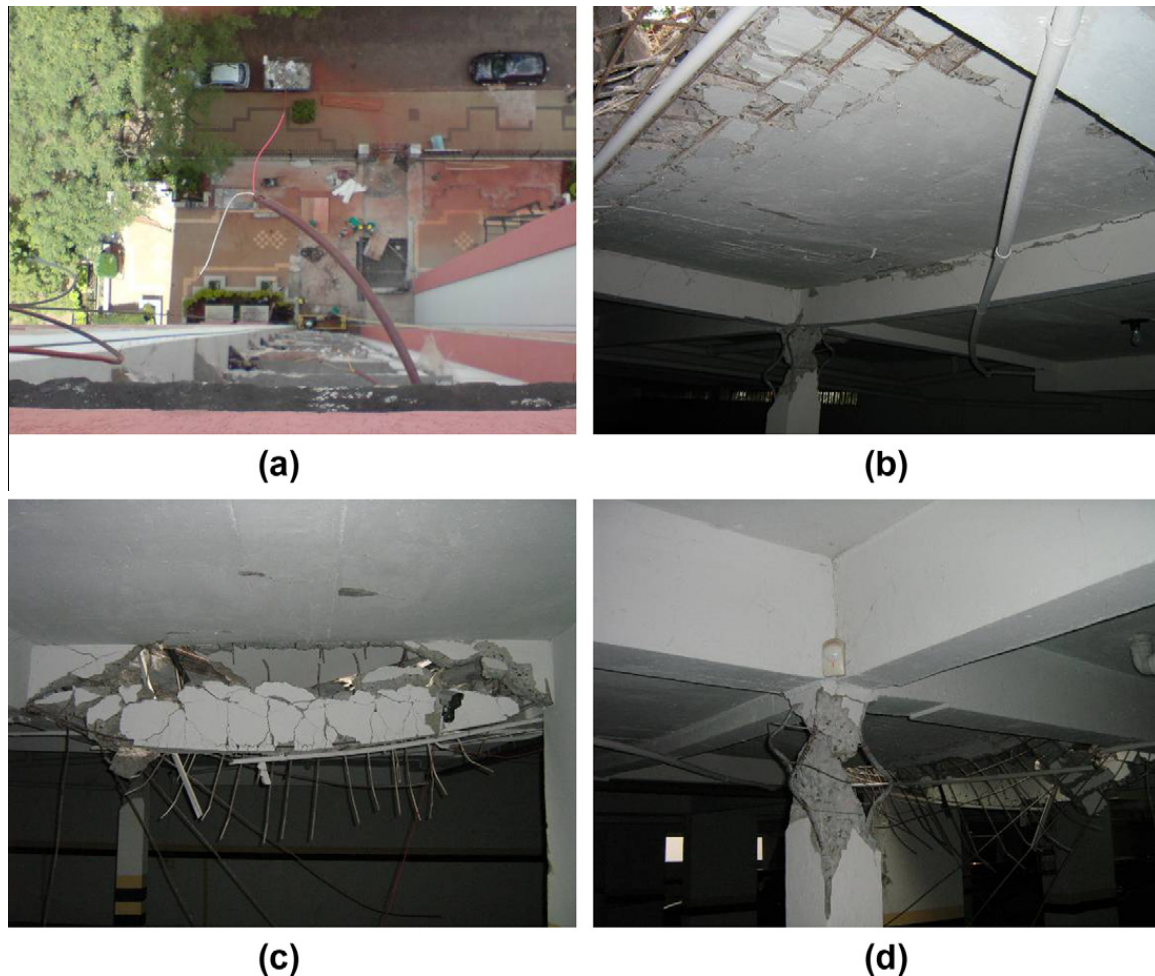
The progressive failure has produced the collapse of one slab situated above the garage in the subsoil, as illustrated in Fig. 3a. As can be seen, there was a trend of deviation of the free-falling debris to the right side of the balconies columns, taking as reference the terrace of the building. This deviation of the debris was probably due to the high stiffness provided in the connection between the slabs of the balconies and the columns P26, as can be seen in Fig. 2a. The progressive failure has given rise to the failure of a slab above the subsoil-garage in the building (Fig. 3b), as well as some beams (Fig. 3c) and columns (Fig. 3d).

**Fig. 3.** (a) Lateral deviation of the debris and subsequent (b) failure of a slabs, beams (c) and columns located at the subsoil garage (d).

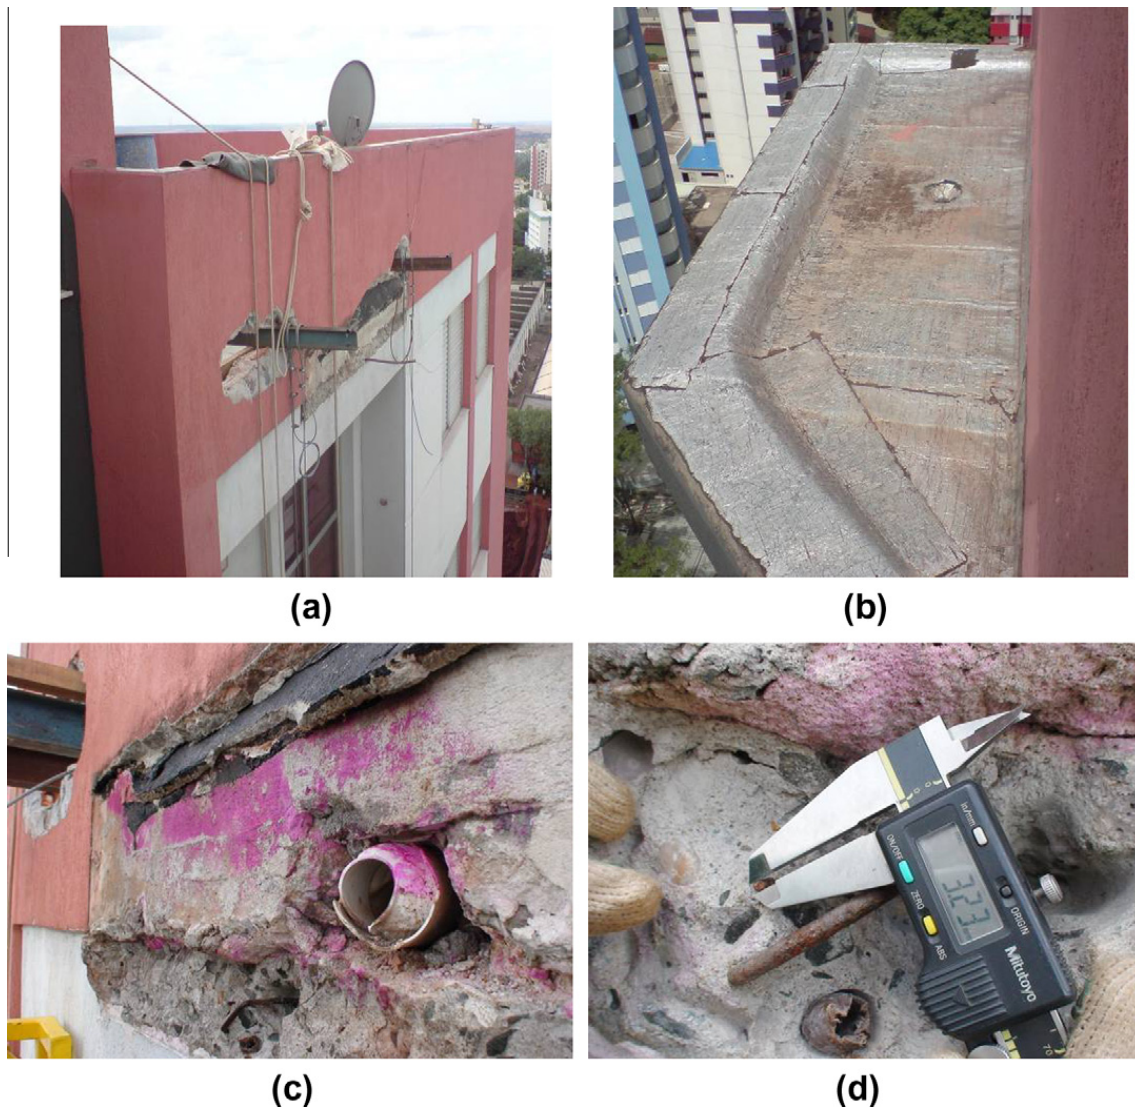
The exaggerated thickness observed for the canopies is result of frustrated attempts aiming to solve humidity problems. As can be seen in the face of the anchorage of the failed canopy (Fig. 4a), there are at least two layers of waterproofing materials as well as exaggerated thickness of mortar for the passage of a run-off water pipeline (Fig. 4c).

Based on a careful analysis, it was possible to raise the hypothesis that the referred run-off water pipeline was object of previous interventions. The hypothesis of leakage was later confirmed by simple tests using phenolphthalein, which revealed the strong presence of humidity in the failed canopy, as show in Fig. 4c. Furthermore, it was realized that the pipeline sit-

**Fig. 4.** (a) Details of the region of detachment of the canopy, (b) non-forecasted loadings acting on the reminiscent canopy, (c) simple test using phenolphthalein for showing a propitious region for corrosion, and (d) decreasing of the main negative bar in the failed canopy indicating corrosion.

In a general way, the agent which has unleashed the corrosion of the main longitudinal bars (negative reinforcement) was the infiltration generated by the rupture of a PVC link connecting the strainer of the canopy to the hydraulic system on the frontage of the building. The region affected in the hydraulic system was above the reinforced concrete canopy and under the waterproofing system as can be seen in Fig. 4c. Taking into account this undesirable infiltration was possible to realize that the main longitudinal steel bars (negative reinforcement) were suffering an advanced process of corrosion, based on the reduction of the initial diameter (Fig. 4d). For the balconies was verified a medium diameter of 5.8 mm for the negative reinforcement when it should be 6.3 mm. For the canopies was verified a medium diameter of 3.0 mm when it should be 3.4 mm.

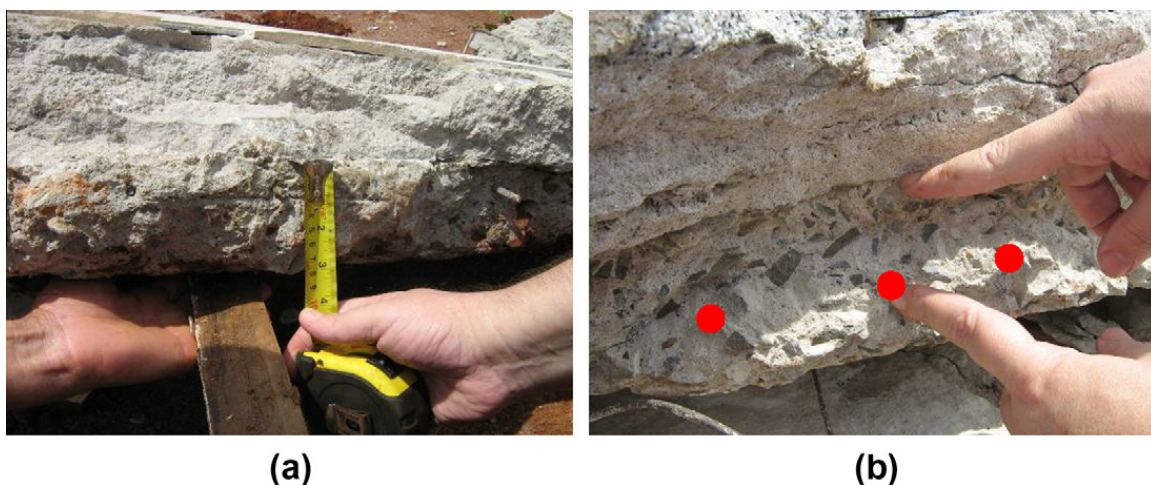
uated above the canopy (Fig. 5b) had an inadequate diameter, enabling in this way the accumulation of water above the canopy, i.e., introducing a non-forecasted extra loading.

Fig. 5a illustrates the exaggerated layers of materials above the balconies slabs while Fig. 5b illustrates the irregularity concerning the spacing between the negative bars as well as its downgrade. As can be seen, the lack of control in the process of execution of this building generated a considerable increasing of loading above the canopies and balconies. It is incredible how this structure was able to carry so many non-forecasted loads for so many years.

Fig. 5. (a) Excessive layers of mortar, filler and coating and (b) detail of the downgrade of the negative reinforcement and lack of uniformity for the spacing between bars.

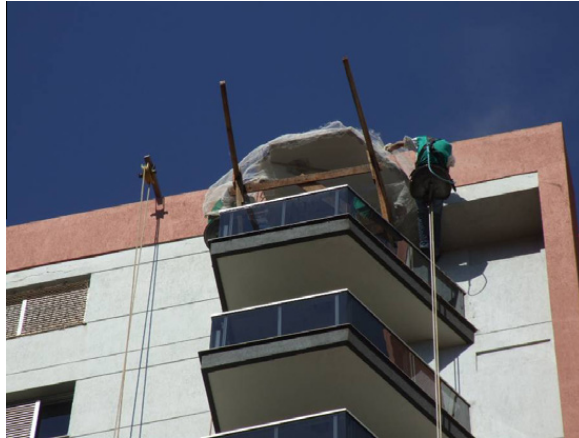
**Fig. 6.** Metal guides installed in the coverage of the building in order to suspend workers using safety belts connected to steel cables.

installed in the coverage of the building, as shown in Fig. 4a. Using the metal guides the workers could be suspended using safety belts connected to steel cables, as shown in Fig. 6.

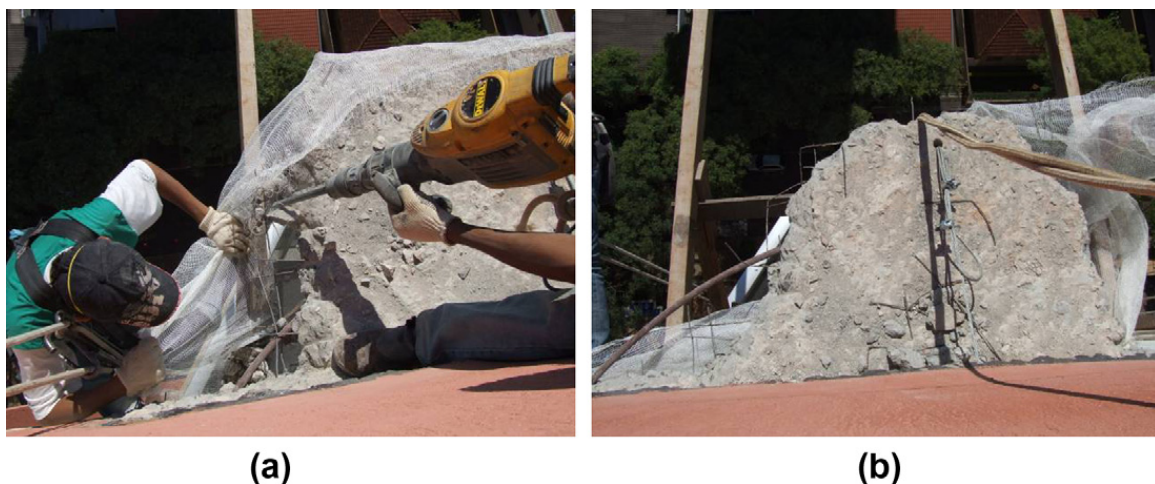
**Fig. 7.** (a) Free-stand slab being demolished using mechanical drill and (b) steel cables providing additional safety for the slab under demolition.

Basically, two workers were responsible for the total demolition of the reminiscent canopy and balconies of the damaged building, as shown in Fig. 7a. In order to avoid the possibility of fall of the cantilevered slabs due to the vibrations produced by the mechanical drill, the slabs have been arrested using steel cables, as shown in Fig. 7b. The slabs were demolished in a very gradual manner, in a way that very small fragments could be gathered in the balcony situated below the slab under intervention.

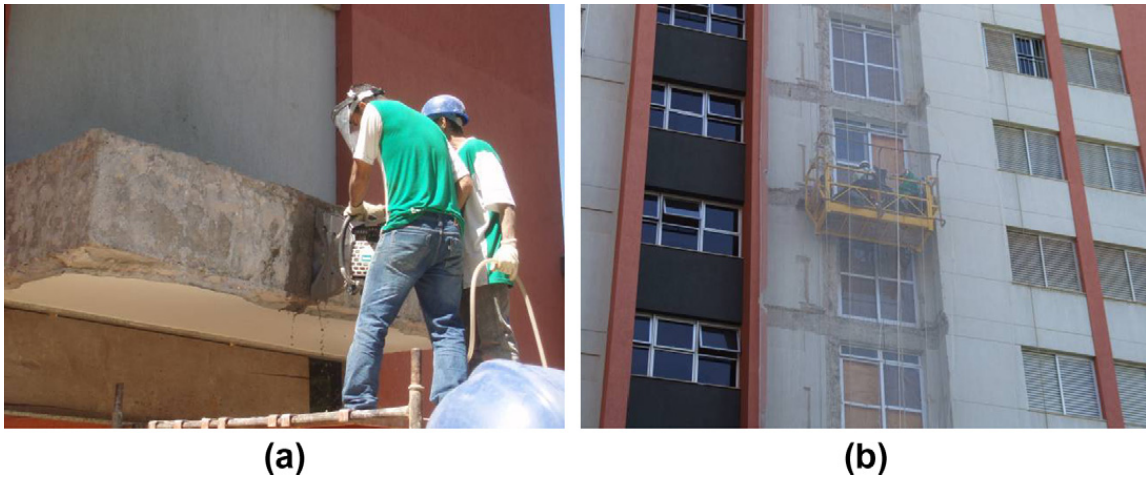
**Fig. 8.** (a) Reinforced concrete pot plant extracted using a diamond saw and (b) installation of a suspended working platform after removing all the reminiscent balconies.

Just above the principal entrance of the building was necessary to apply a diamond saw, taking into account the presence of a very rigid structural configuration provided for a reinforced concrete plant cup, as show in Fig. 8a. Once the canopy and all the balconies have been removed, a suspended working platform has been installed, in order to help the reconstruction of new canopies and balconies, as shown in Fig. 8b.

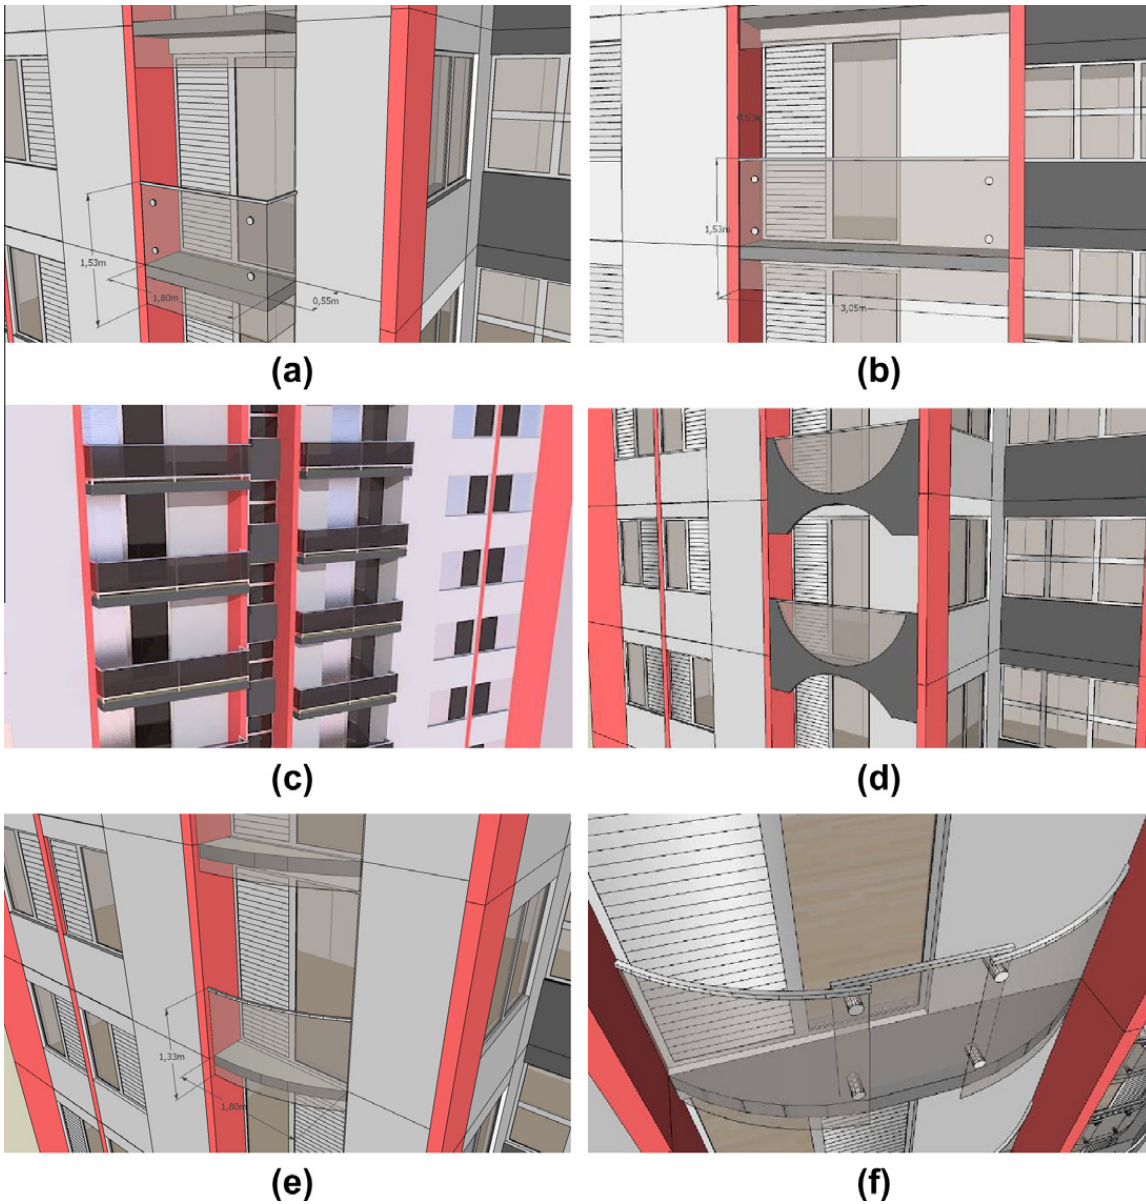
**Fig. 9.** Proposals for reconstructing the balconies of the building using (a) a reduced rectangular balcony, (b, c, d) extended rectangular balconies with different aesthetics effects, (e) a demilune balcony and (f) a semicircular balcony.

However, after analyzing the strength of some structural elements and some architectural possibilities using mixed structural systems in the region of the damaged balconies, it was possible to develop some proposals for the reconstruction of the failed/demolished balconies, as shown in Fig. 9.

After many meetings, the owners of the apartments have decided for the reconstruction of the balconies, following the proposal presented in Fig. 9c. This decision was mainly made based on the minimum disturbance that the reconstruction will lead, as well as the visible gain of area that this reconstruction will produce. Fig. 10a shows the original dimension of the failed/demolished balconies while Fig. 10b shows the proposal of reconstruction.

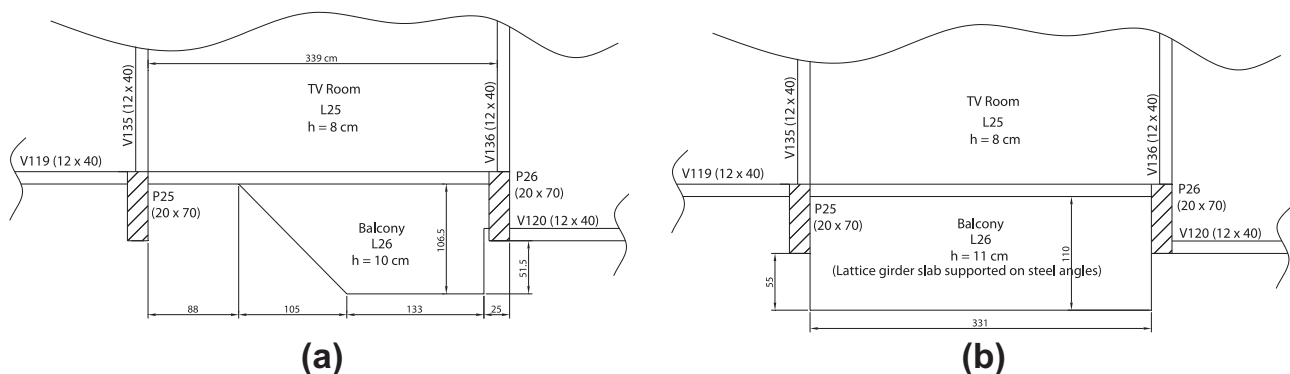
Fig. 10. (a) Original dimensions of the failed/demolished balconies and (b) dimensions of the approved proposal for the reconstruction of the balconies.

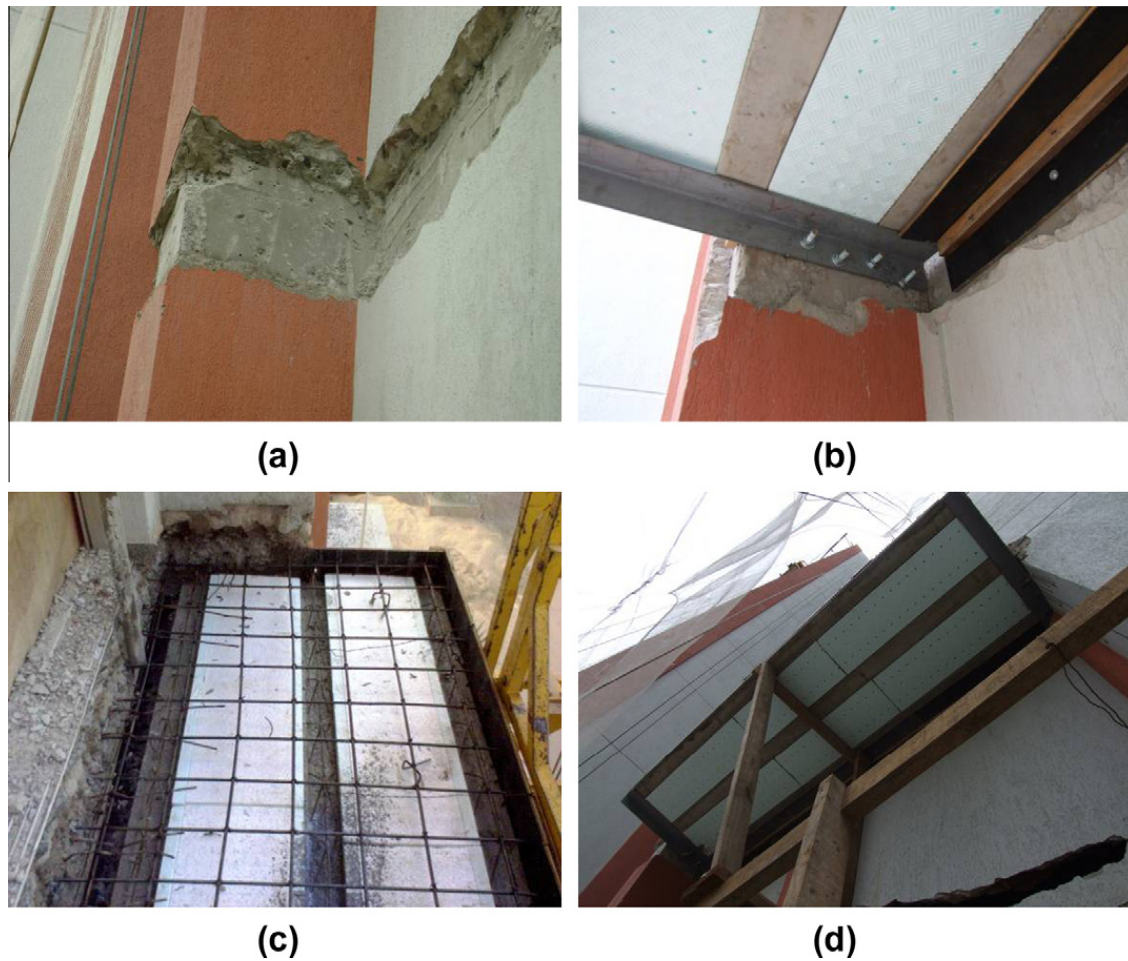
**Fig. 11.** (a) Scarification of the layers of mortar covering the columns, (b) details of the steel angles bolted with galvanized bolts, (c) superior view and (d) inferior view of the new balconies.

After finishing the design of the structural elements to be used in the new balconies, the process of scarification of the regions of covering of the columns was conducted, in order to install the lateral steel angles, as shown in Fig. 11a. After this activity, the steel angles were bolted, as show in Fig. 11b, and the lattice girders beams were accommodate in order to form the formwork for the new slabs.

Fig. 11c shows a superior view of the structure while Fig. 11d shows an inferior view of the new balconies, where is possible to observe the steel angles, the line of bolts, the lattice girders beams and the expanded polystyrene (EPS) elements before casting the slabs. As can be seen in Fig. 11c, before the casting of the slabs with concrete, an orthogonal reinforcement mesh constituted by 8 mm bars spaced by 18 cm was positioned just above the expanded polystyrene elements.

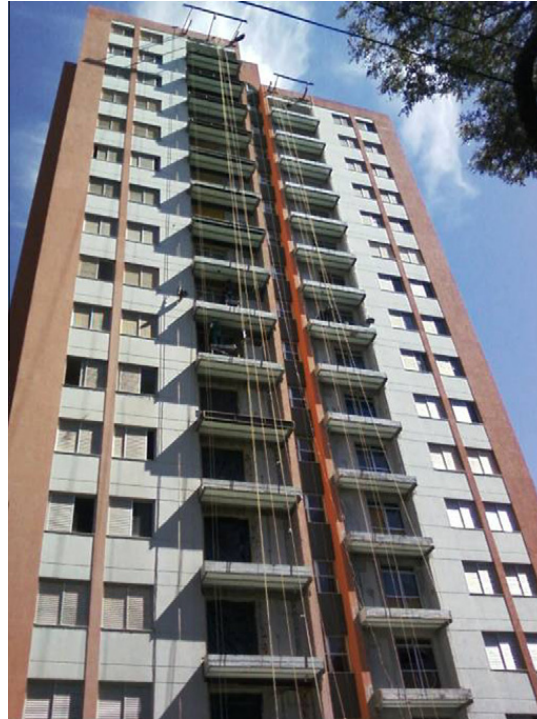
**Fig. 12.** Frontage of the damaged building after the reconstruction of the failed/demolished balconies.

problems were identified during the activities. Fig. 12 shows the frontage of the damaged building with the reconstructed balconies and canopies.
